**UNDERWATER FACILITIES
INSPECTIONS
AND
ASSESSMENTS
AT

U.S. NAVAL STATION

ROOSEVELT ROADS, P.R.**

FEBRUARY 1982

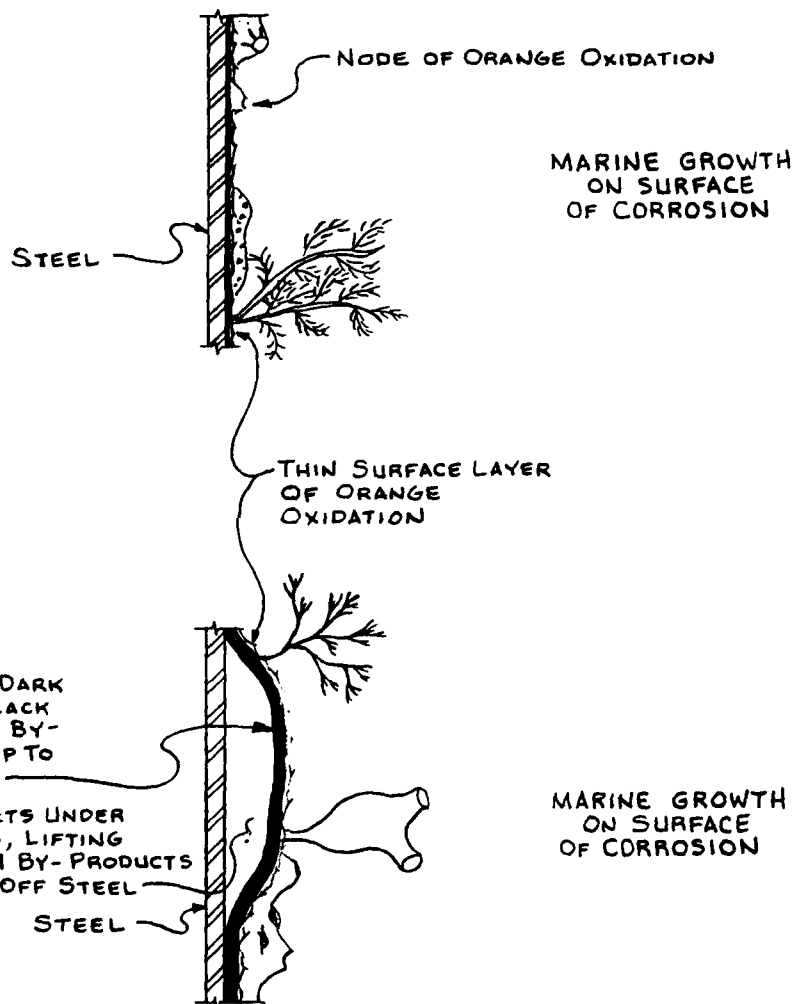
GRAPHIC SCALE	CHILDS ENGINEERING CORPORATION P.O. BOX 333 MEDFORD, MA	CHESAPEAKE DIVISION NAVAL FACILITIES ENGINEERING COMMAND WASHINGTON, D.C.	FIG. NO.
N/A		NAVAL COMPLEX ROOSEVELT ROADS, PR	4
TYPICAL CORROSION BUILDUP

On the older facilities with steel piles, deposits of black corrosion by-product with gas pockets trapped beneath were not uncommon. This corrosion buildup was not heavy, usually less than 1/4" thick. Patches of orange oxidation were seen on all steel structures, particularly at any interface between concrete and steel. Both types of corrosion are illustrated in Figure 4 .

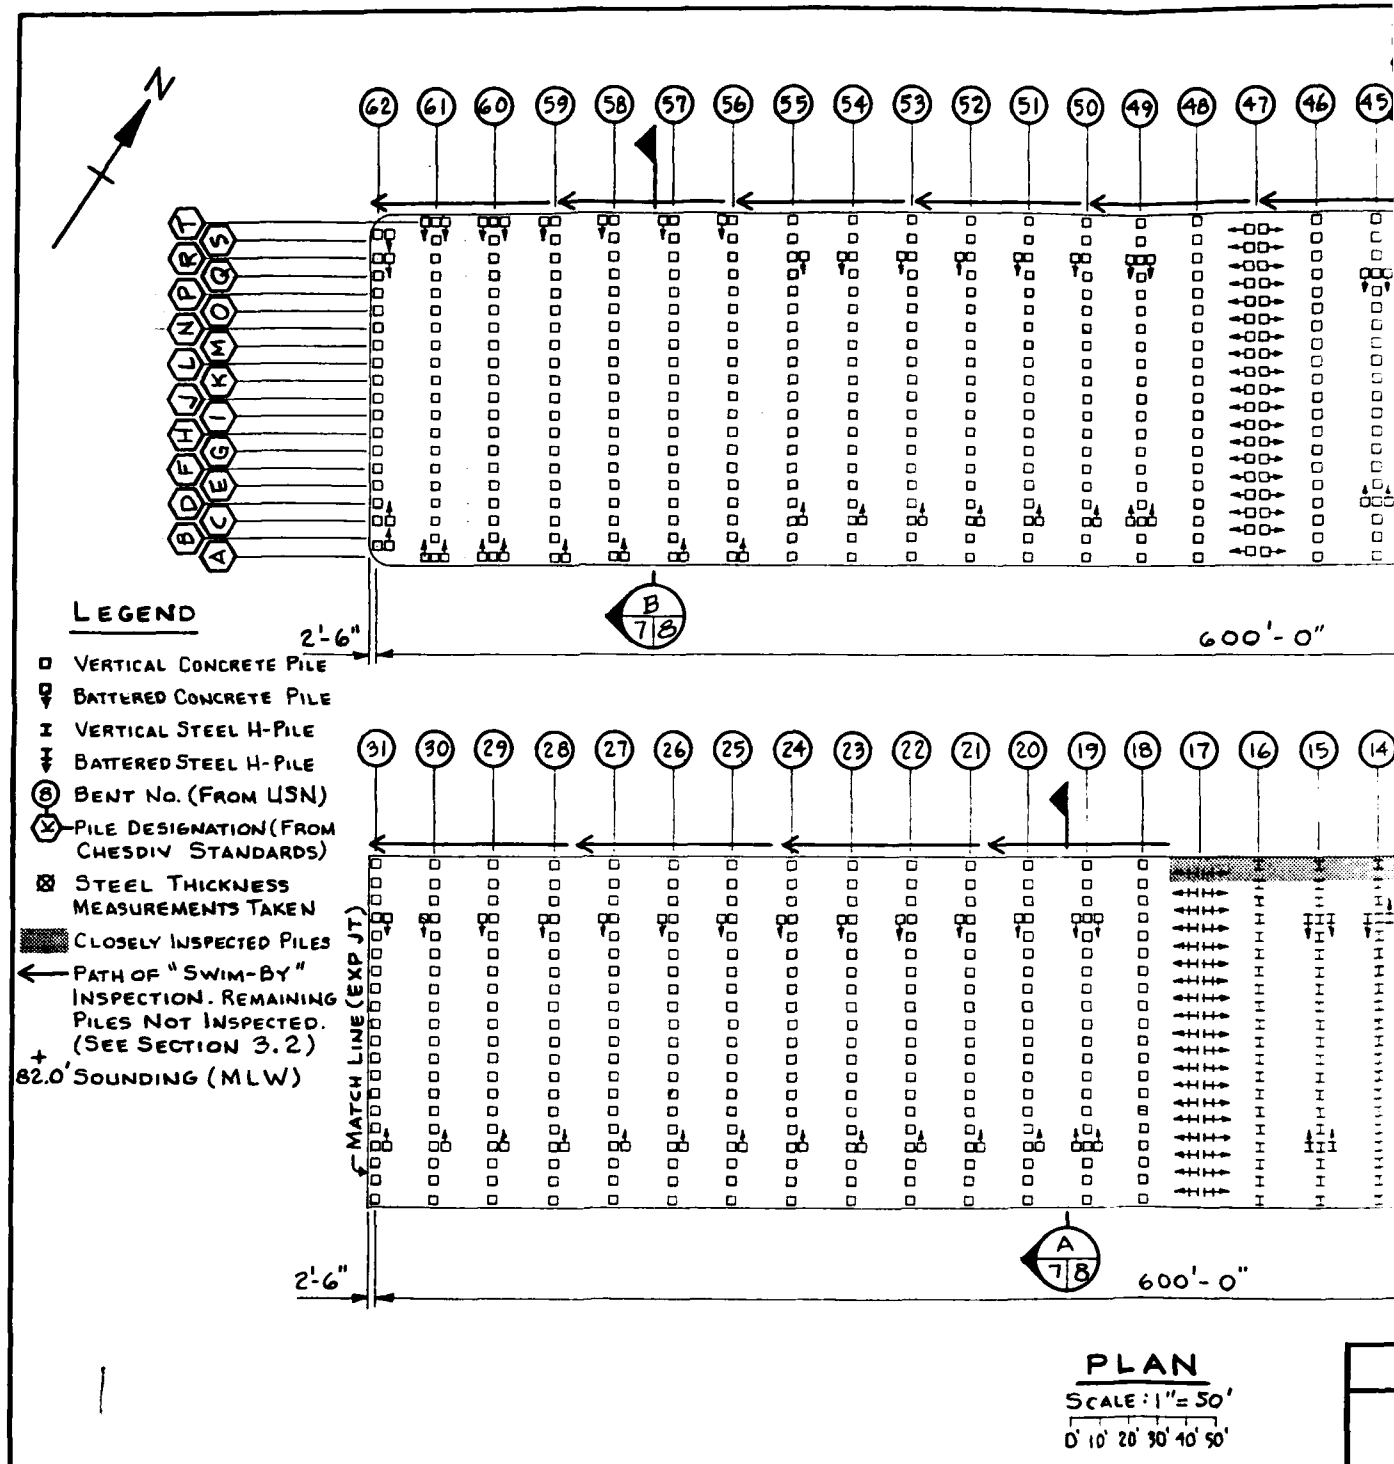
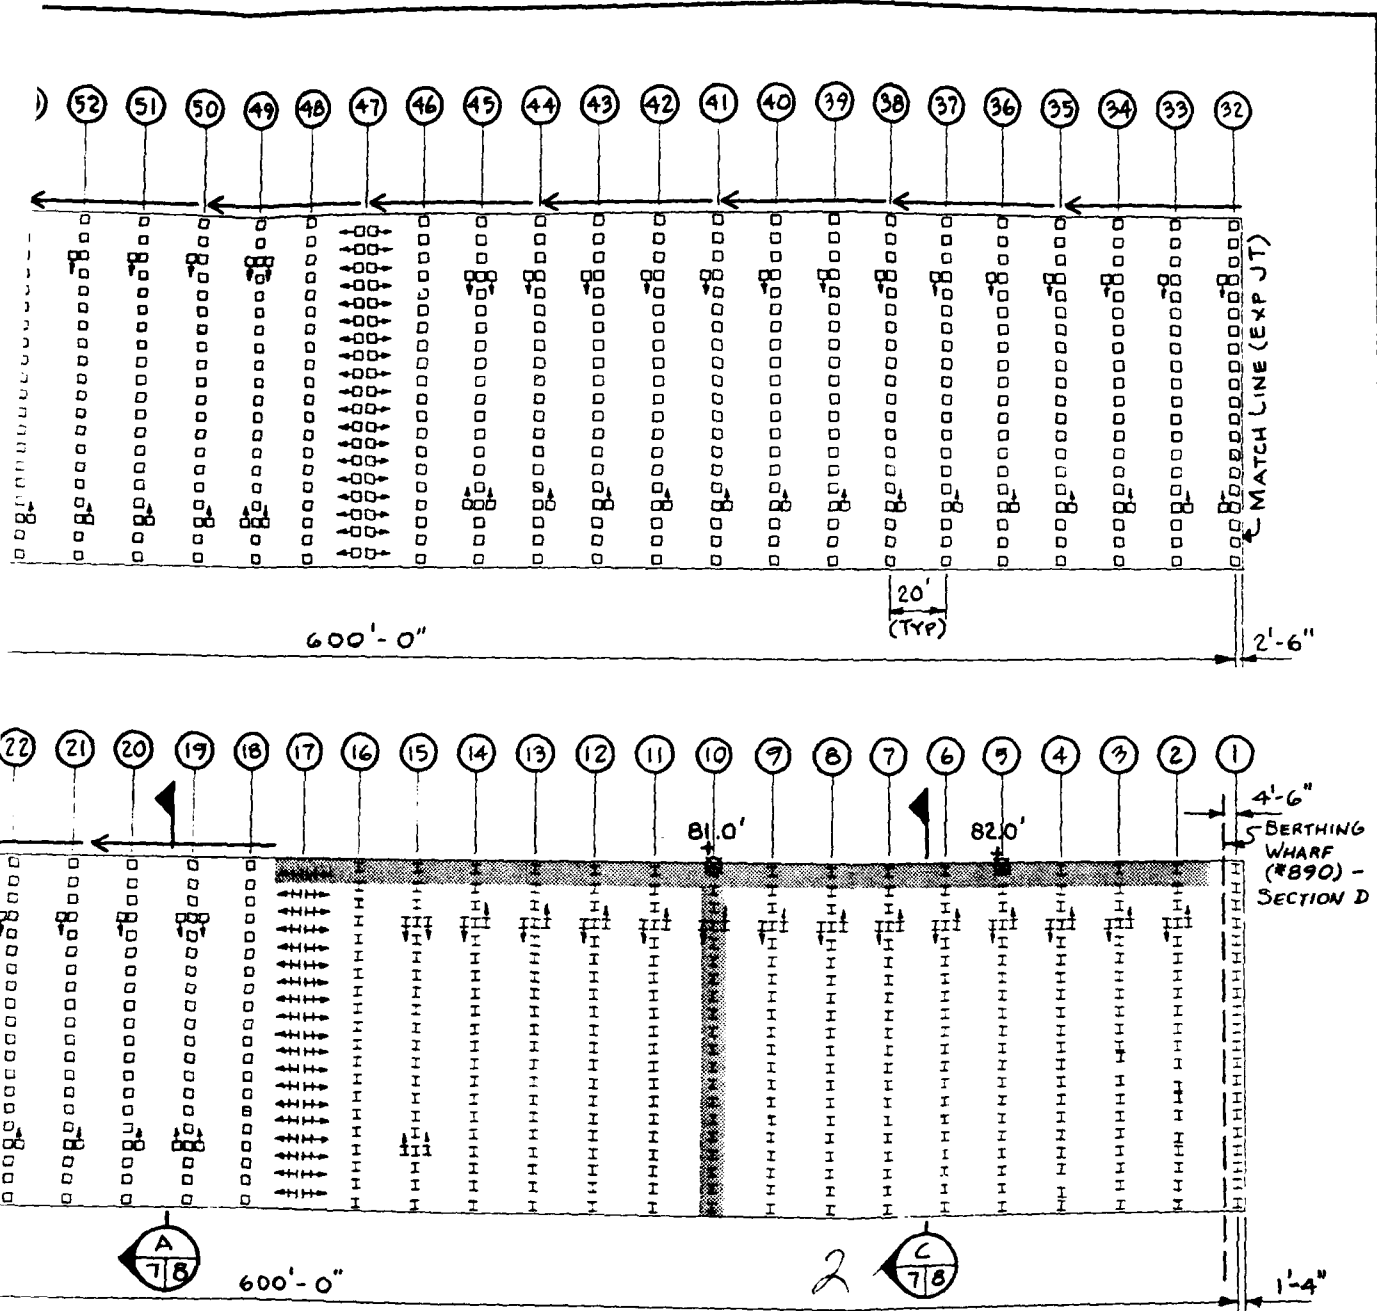
NAVAL COMPLEX ROOSEVELT ROAD, PR
BERTHING PIER (#799)

One concrete pile exhibited severe structural deterioration, probably due to impact from a berthing vessel (Pile A, specific bent unknown). The pile is completely severed just below the pile cap (see Photo #8). No major spalling, cracking or softness was observed on the remaining concrete piles (see Photo #9).

The jacketed steel piles exhibited some minor cosmetic spalling on the concrete jackets (see Photo #10). The exposed portions of the steel piles had suffered minor corrosion and exhibited some pitting (see Photo #11). Two piles were measured to determine the extent of corrosion. The average metal loss on these piles was between 2% and 4% (see Appendix for readings).

have a damaged pile which must be repaired or replaced as soon as possible, but neither pier's capacity needs to be downgraded. Also, the steel sheet pile bulkhead at the base of the Supply Pier should be protected with a concrete encasement to prevent further deterioration.

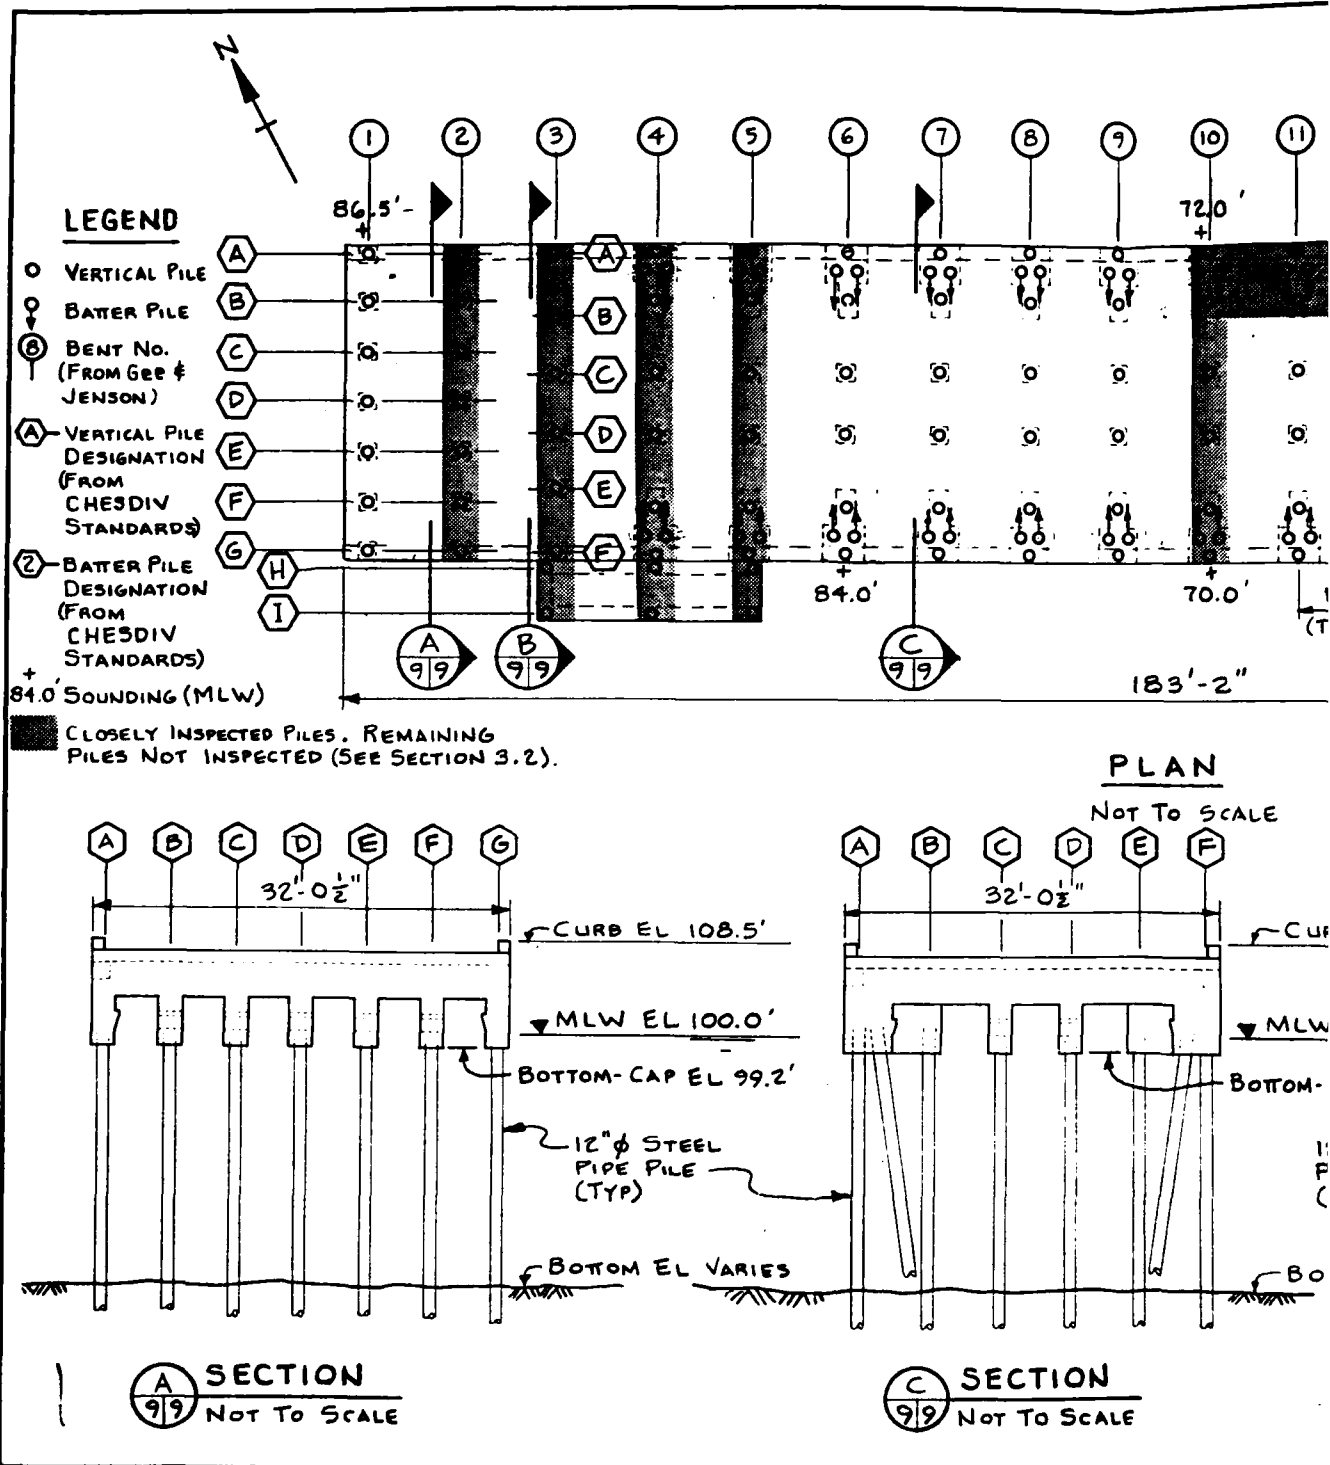
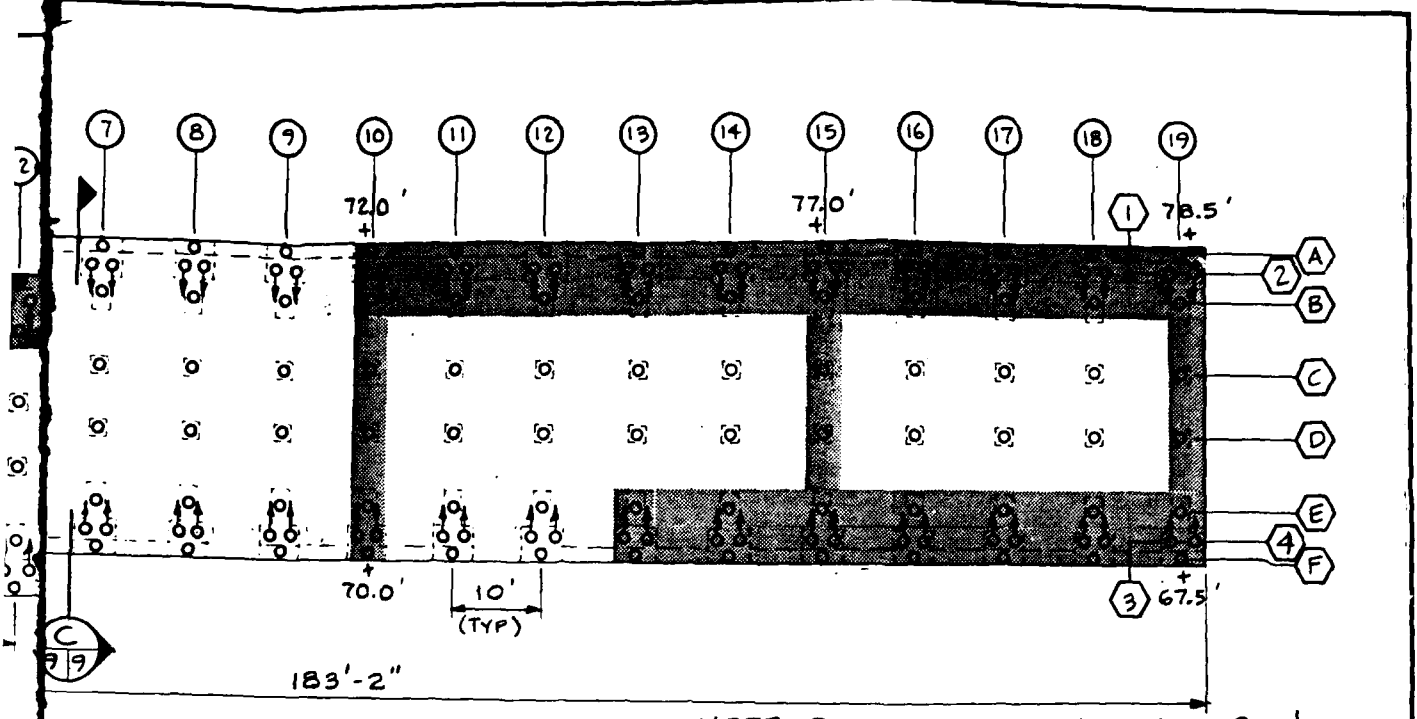
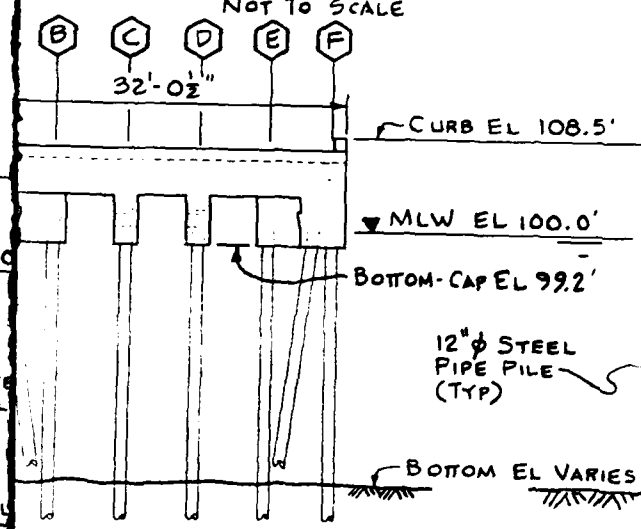
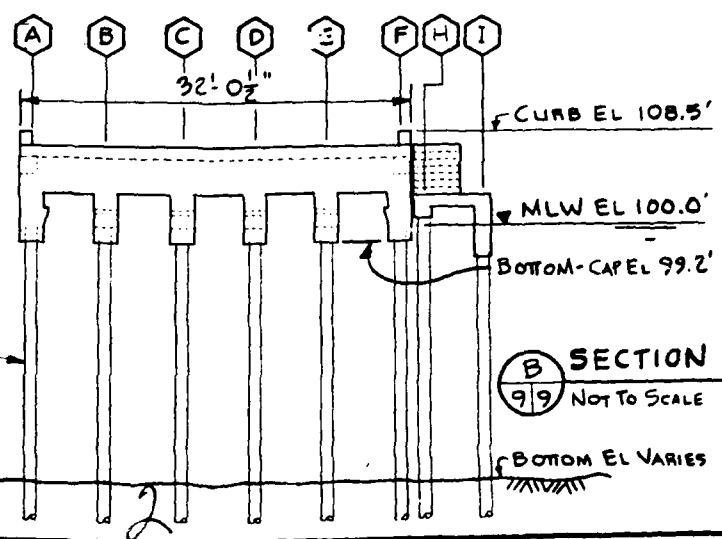
GRAPHIC SCALE	CHILD'S ENGINEERING CORPORATION BOX 883 MEDFIELD, MA	CHESAPEAKE DIVISION NAVAL FACILITIES ENGINEERING COMMAND WASHINGTON, D.C. NAVAL COMPLEX ROOSEVELT ROAD, PM AMMUNITION PIER (#277)	FILMO. 9
AS SHOWN

The 183' long x 32' wide pier was built in 1943. The reinforced concrete deck is supported by 19 bents with a total of 64 batter and 122 vertical bearing piles. The piles are 12" diameter steel pipe piles (see Figure 9).

The submerged portions of the concrete pile cap exhibited some softness in the concrete. In general, however, the concrete was sound. The remainder of the superstructure, including pile caps and concrete support beams, exhibited varying degrees of deterioration (see Photo #13). Many areas of the concrete were spalled and, in some cases, reinforcing was exposed and rusting.

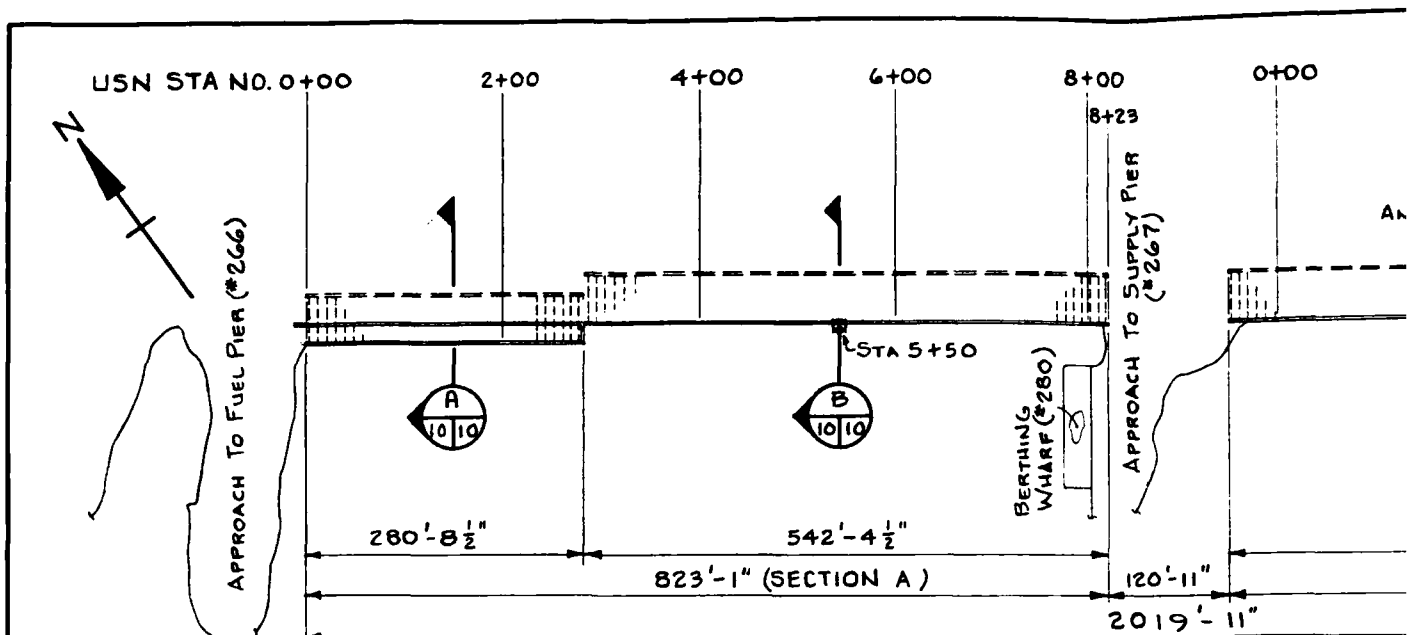
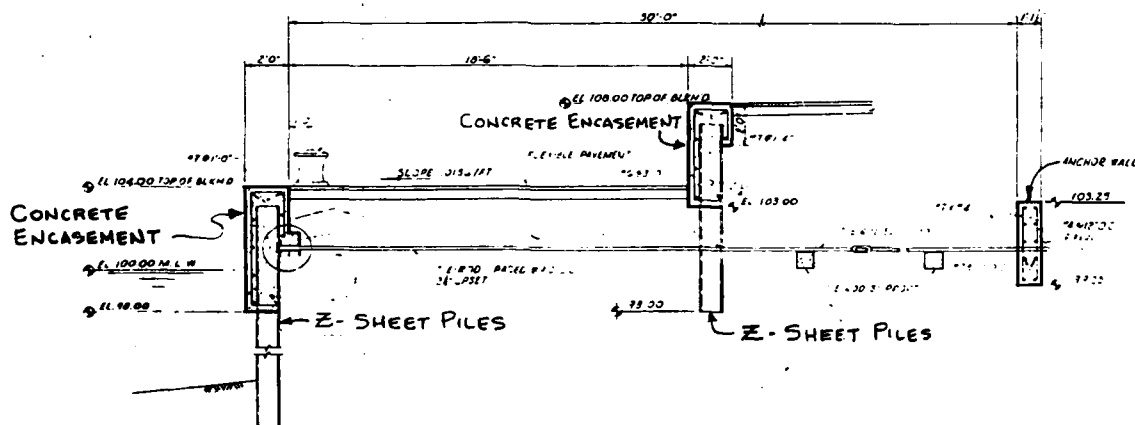
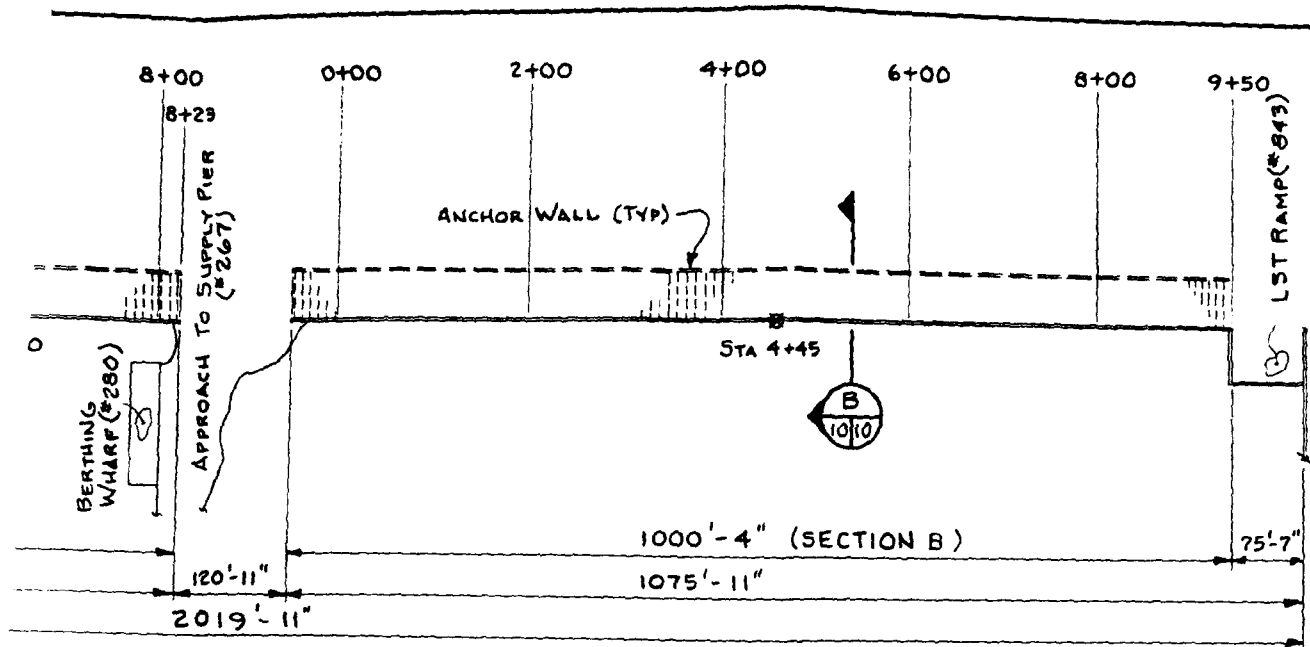
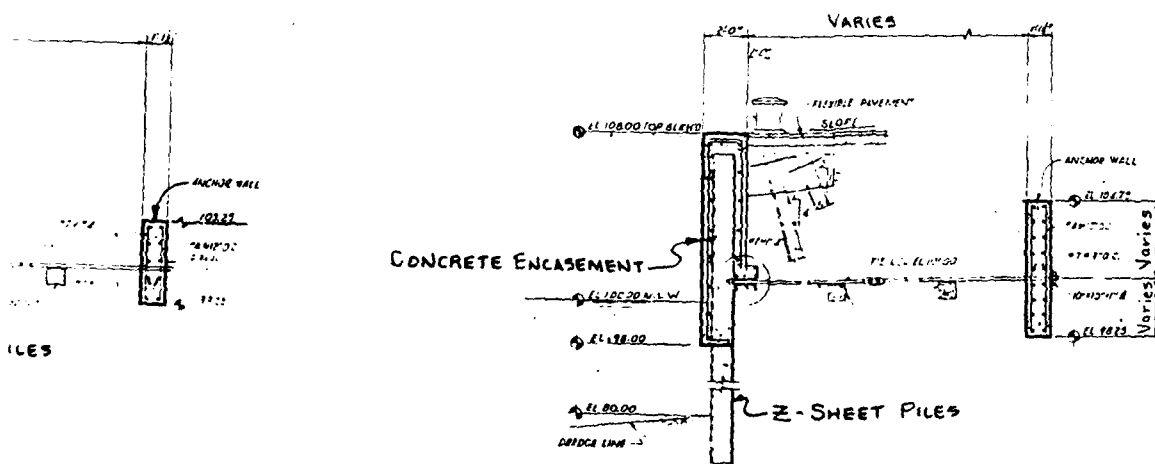
GRAPHIC SCALE	CHLDS ENGINEERING CORPORATION BOX 333 MEDFIELD, MA	CHESAPEAKE DIVISION NAVAL FACILITIES ENGINEERING COMMAND WASHINGTON, D.C.	
AS SHOWN		NAVAL COMPLEX ROOSEVELT ROAD, PM BERTHING WHARF (#890) SECTIONS A & B	FIG. NO. 10

The 3,738' long x 12' wide Berthing Wharf is a bulkhead that was built in 1965 and is composed for four distinct sections. Section A is 823' long and runs between the Fuel Pier and the Supply Pier. Section B is 1,000' long and runs in a southeast direction from the Supply Pier to a 90° corner made by the LST Ramp (843). Section C is 813' long and runs southwest from the LST Ramp. At the end of Section C, the wall makes a 68° turn to the southeast. This is Section D, which is 1,101' long. It runs under the Berthing Pier and beyond before making a change in direction. The last 227' of the section, which were not inspected, run in a northerly direction (see Figures 10 and 11).

The bulkheads are anchored steel sheet pile walls constructed of Z sections. According to government-furnished information, the steel sheet piling are mainly Z-27 sections. The exception to this is a 217'-long segment of Section C (between CEC Stations 7+60 and 5+40) that is shown to be composed of Z-38 sections. For most of its length, the Berthing Wharf is capped and encased by reinforced concrete down to elevation 98.0' (see Photo #14). The design stress for the tie rods, wales and sheet piles is 22,000 PSI.

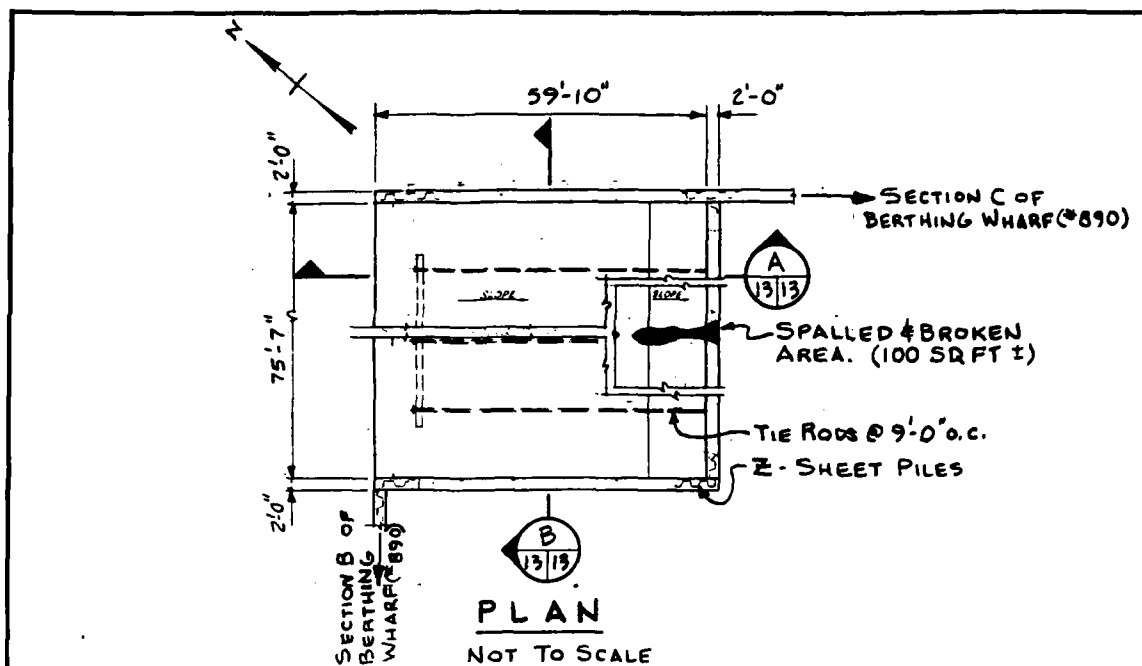
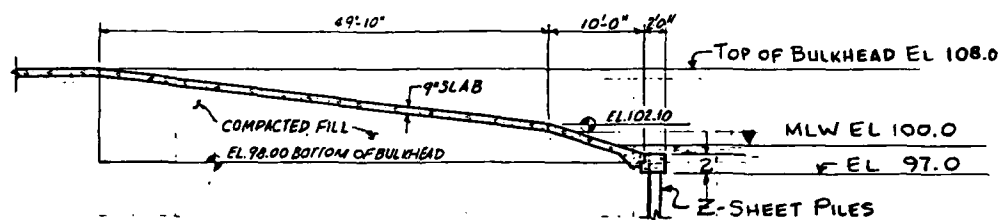
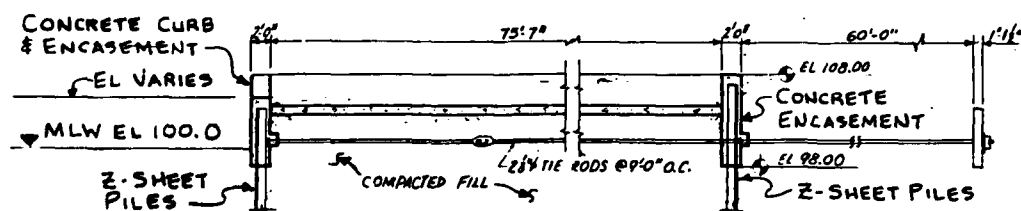
GRAPHIC SCALE	CHILDS ENGINEERING CORPORATION BOX 881 MEDFIELD, MA	CHESAPEAKE DIVISION NAVAL FACILITIES ENGINEERING COMMAND WASHINGTON, D.C.	FIG. NO.
AS SHOWN		NAVAL COMPLEX ROOSEVELT ROAD, PR LST RAMP (#843)	13

The 62' long x 80' wide ramp was built in 1963. It is comprised of a perimeter, anchored steel sheet pile bulkhead filled with compacted granular material. The ramp itself is a cast-in-place, reinforced concrete slab placed on the granular fill (see Figure 13). The steel sheet pile wall is constructed of Z-27 sections.

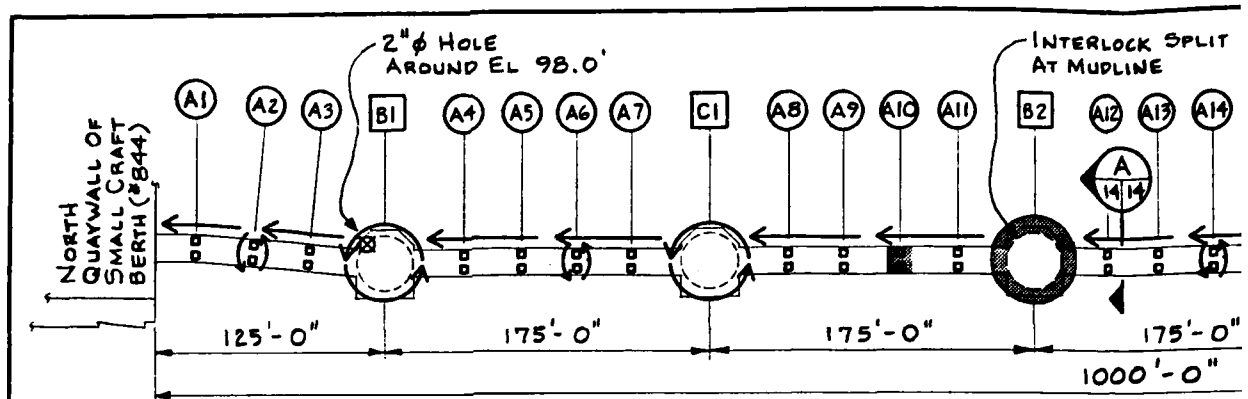
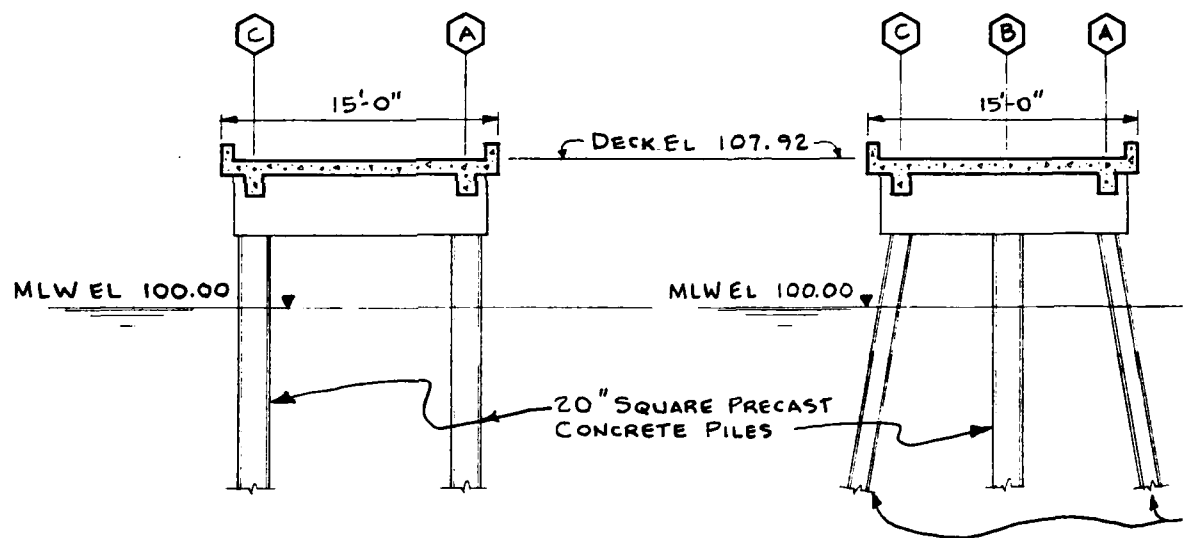
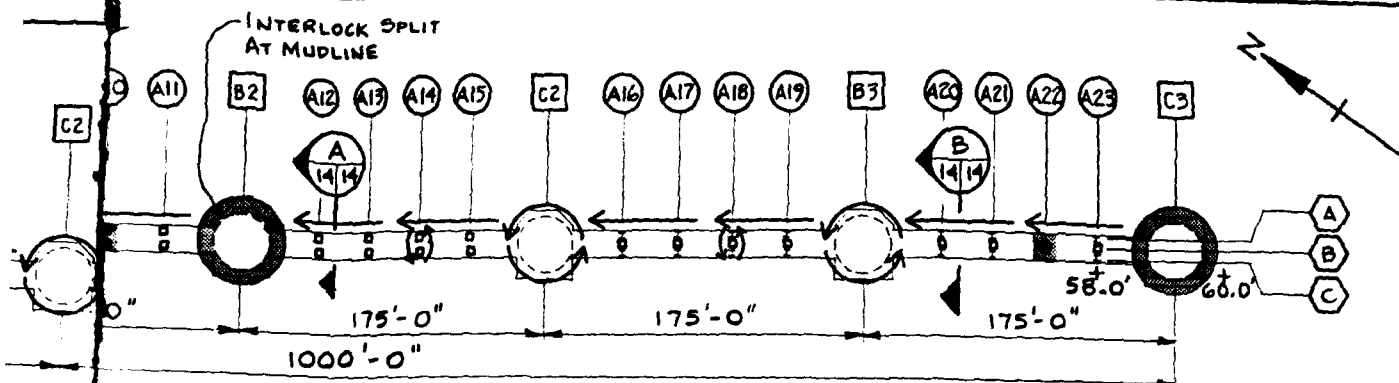
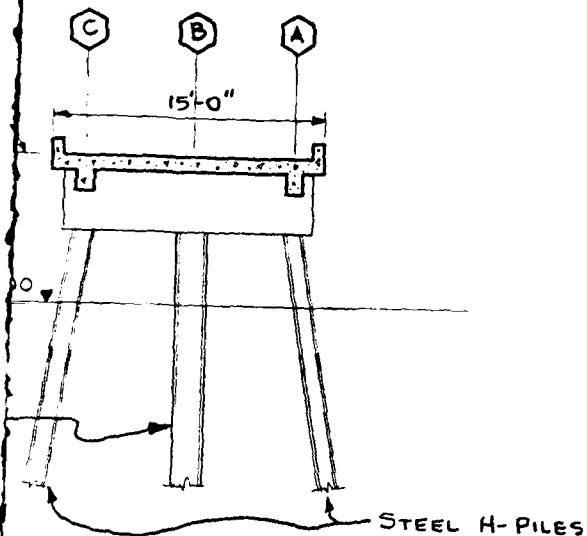
FIG. NO.
14

The Approach Pier was built in 1944. The 1,018' long x 15' wide pier is supported by six rock-filled steel sheet pile cylinders and 23 bents (see Figure 14). The cylinders are 30' - 6 5/8" in diameter and are constructed of M-112 sections. The bents are composed of 38 20"-square precast, reinforced concrete piles and 16 steel HP 14x89 piles. The concrete piles have a design bearing capacity of 50 tons. The reinforced concrete deck has a design live load of 200 PSF uniform loading.

The concrete piles which support the reinforced concrete deck between the steel sheet pile cylinders exhibited some softness around mean low water. The steel H-piles at the outshore end of the Approach Pier exhibited minor to moderate corrosion. The steel sheet pile cylinders exhibited severe deterioration around mean low water and in the splash zone (see Photo #19; see Appendix for thickness readings). Holes were evident in the splash zone area and could be created in the area just below mean low water with the aid of a chipping hammer (see Photo #20 and Figure 14). At Cylinder B2, a split interlock was found, extending from the mudline up 4' (see Figure 14). A void was noted through the split indicating that a substantial amount of fill material had been lost from the cylinder.

Repair work is recommended for the remaining facilities. The most extensive work is required at Approach Pier (273), which should be removed if it is no longer necessary, and at the Small Craft Berth on Vieques Island, which should be replaced with an entirely new facility. The concrete slabs in both of the LST Ramps should be repaired along their submerged edges, although more extensive patching as well as pressure grouting are necessary at the Naval Station's LST Ramp (843). The Supply Pier (267) and Berthing Pier (799) each have a damaged pile which must be repaired or replaced as soon as possible, both neither pier's capacity needs to be downgraded. Also, the steel sheet pile bulkhead at the base of the Supply Pier should be protected with a concrete encasement to prevent further deterioration.

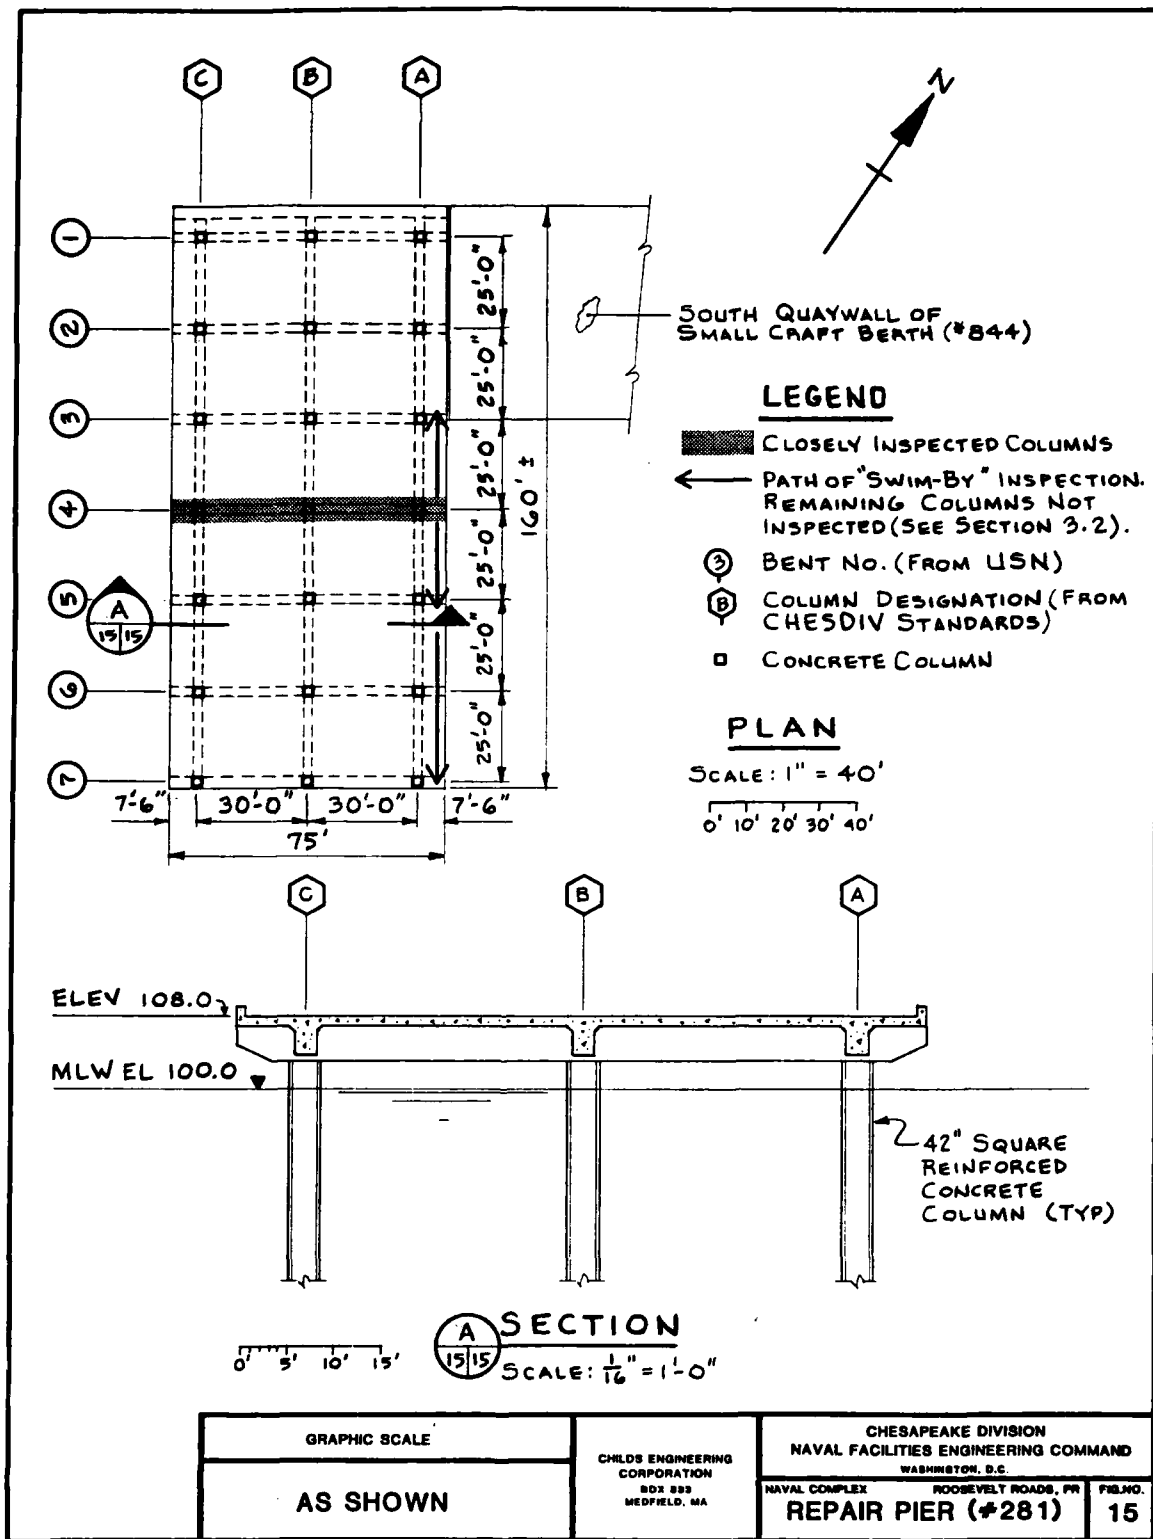
The 160' long x 75' wide Repair Pier was built around 1943. The reinforced concrete decking is supported by seven bents of 42" square reinforced concrete columns, apparently resting on concrete pedestals. There are a total of 21 vertical bearing columns (see Figure 15).

No major structural deficiencies were observed in the reinforced concrete column foundation of the Repair Pier. Some softness was noted in the concrete columns around mean low water.

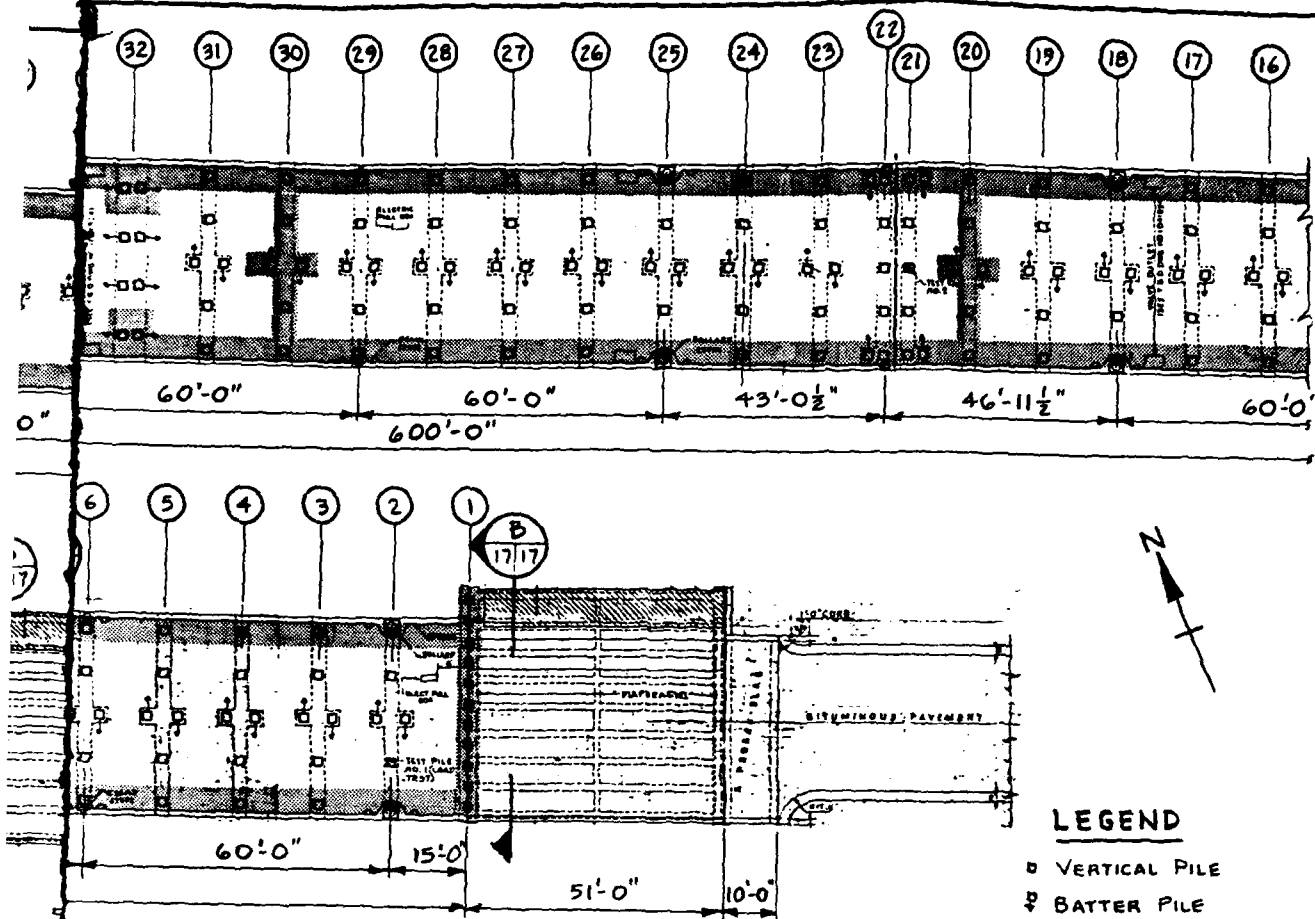
GRAPHIC SCALE	CHILDS ENGINEERING CORPORATION BOX 388 MEDFORD, MA	CHESAPEAKE DIVISION NAVAL FACILITIES ENGINEERING COMMAND WASHINGTON, D.C.	NAVAL COMPLEX ROOSEVELT ROAD, PR AMMO PIER - VIEQUES (#2018)	FILE NO. 17
AS SHOWN

No major structural deterioration was observed at the Ammunition Pier on Vieques Island. In general, all the piles were sound and exhibited little or no softness. Little or no spalling or cracking was observed. No significant cracking or spalling was noted in the pile caps or the superstructure.

The Ammunition Pier on Vieques Island is in excellent condition. No structural abnormalities or severe deterioration was observed which would reduce the capacity of the pile foundation. Any spalling or cracking noted is not structurally significant.

No repairs are required at this time. The Ammunition Pier should be reinspected in ten years to document any further deterioration. This report should be used as a baseline for future inspections.

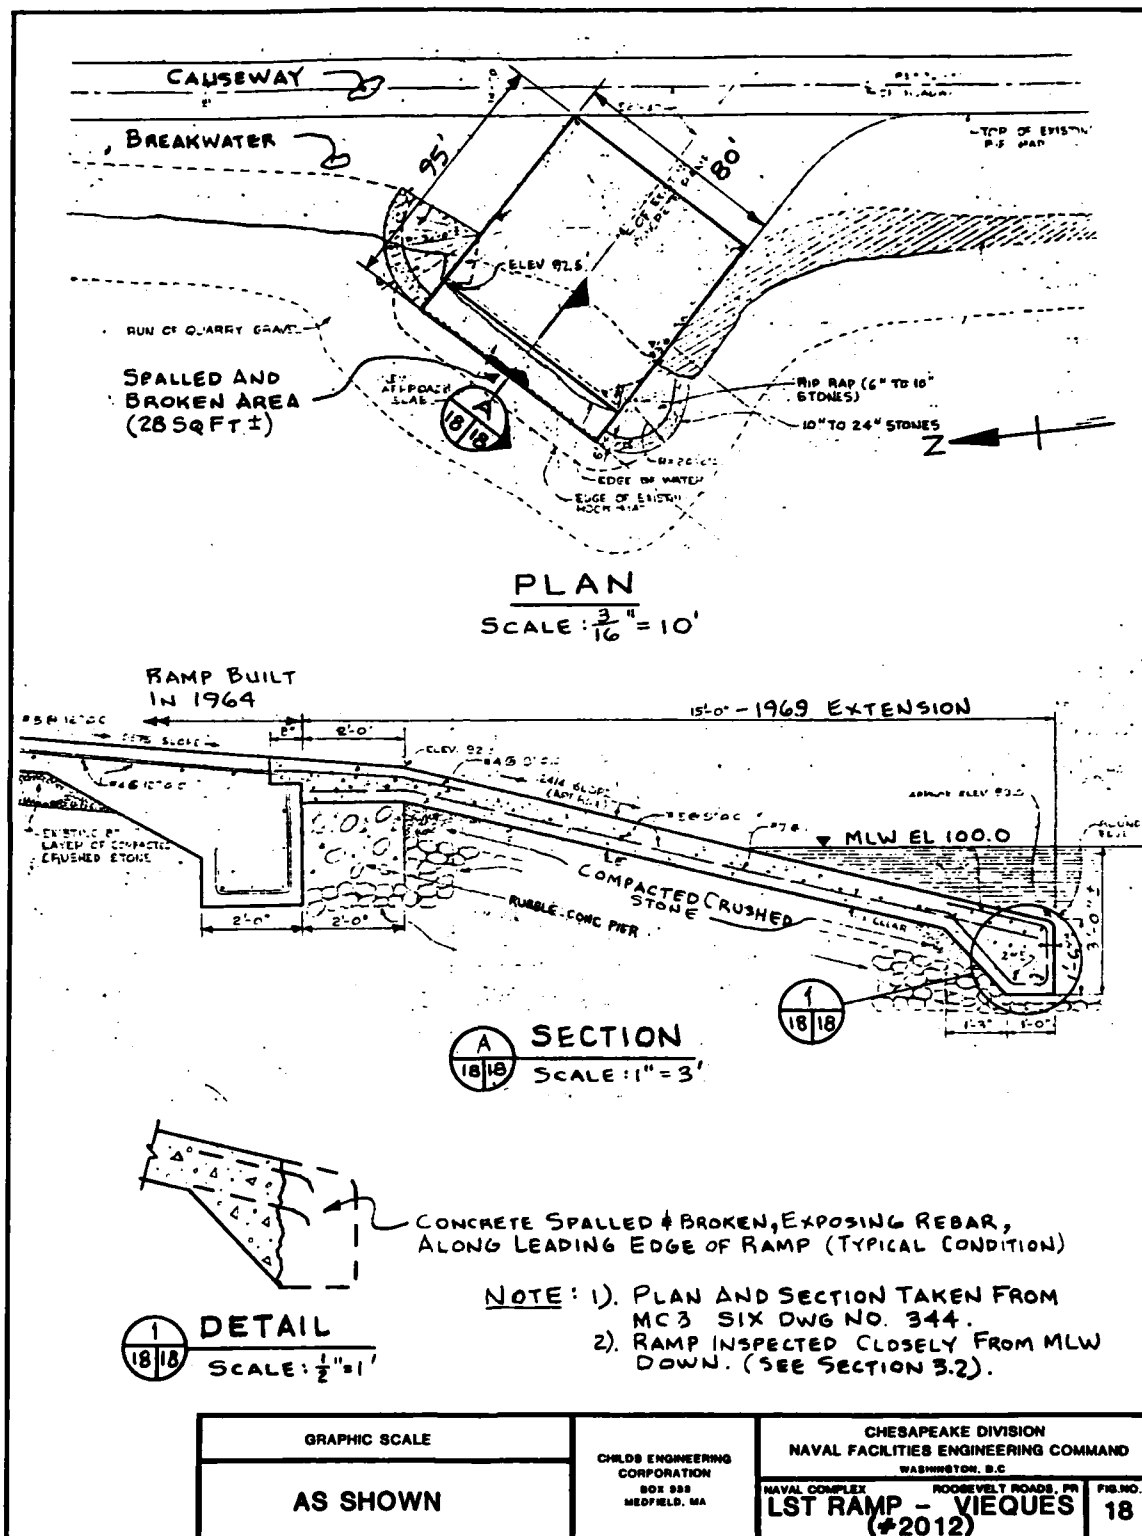
Severe spalling of the concrete was noted along the submerged edge of the LST Ramp on Vieques Island (see Figure 18). Reinforcing was exposed in this area and in a deteriorated condition. In general, the remainder of the concrete ramp appeared sound.

In general, the LST Ramp on Vieques Island is in good condition. The spalling and deterioration along the submerged edge of the ramp should be repaired to prevent further deterioration.

The submerged edge of the LST Ramp on Vieques Island should be repaired by patching with epoxy mortar. Prior to the placement of the new mortar, the existing concrete should be chipped to sound concrete and deteriorated reinforcing should be replaced. The new epoxy mortar should be placed or cast against the existing concrete. The estimated cost for these repairs is \$11,000.

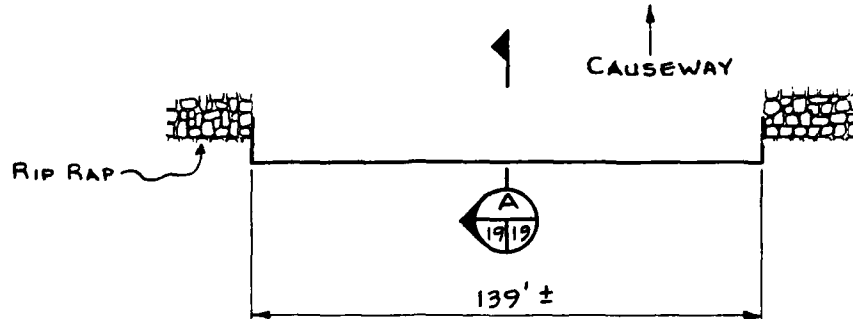
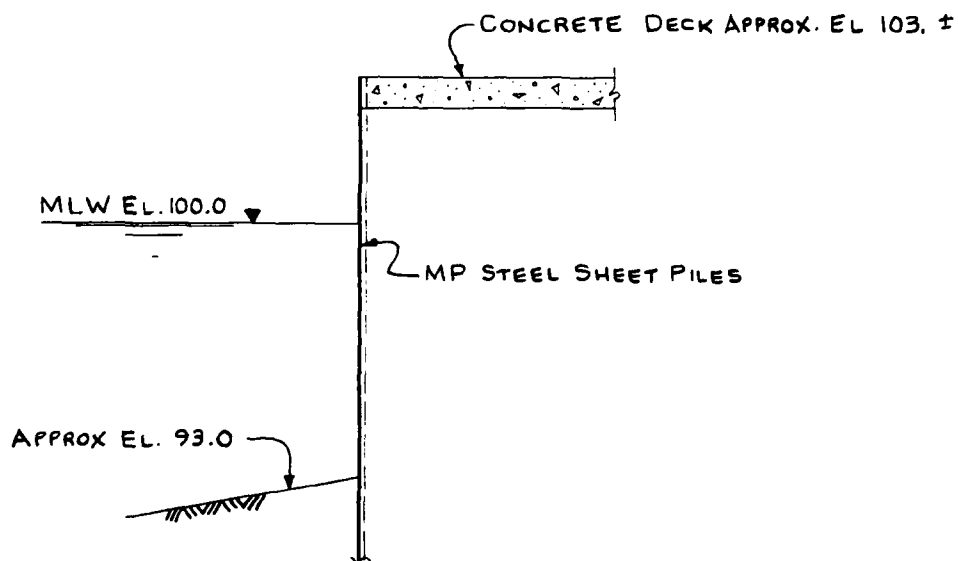
The steel sheet pile wall was severely deteriorated around mean low water and in the splash zone. Holes were noted over 50% of the steel sheet piling in the splash zone area. In the area just below mean low water, the wall was severely corroded, and holes could easily be made in the steel with a chipping hammer. The steel sheet piling were also deflected outward, indicating that the imposed soil loads exceeded the wall's capacity.

The Small Craft Berth on Vieques Island is in poor condition. It has already experienced partial failure as evidenced by the severe outward displacement of the steel sheet pile wall. It appears that current use of the facility is minimal and perhaps restricted.

The facility should be used with caution due to its advanced state of deterioration. Government-furnished information indicates that a new design was developed for a Small Craft Berth at Vieques Island, implying that this facility has been in poor condition for some time. It is recommended that the present facility be abandoned and the proposed facility be constructed. Based on the details of the proposed design, the estimated cost for replacement of this facility is \$360,000.
